# Manhole Inspection Summary

Manhole # S23GG1025MH

**Location** Address: **1403 REDFERN AVE**

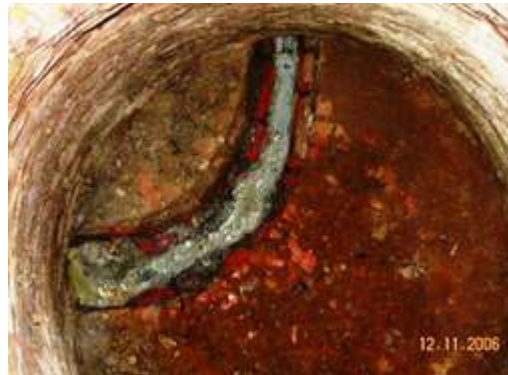
Top View

Evidence of surcharge - Bench debris.  
Channel debris.

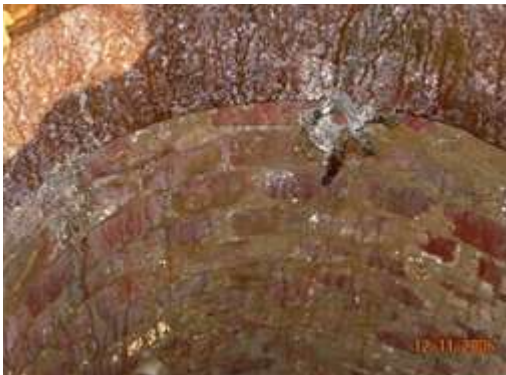
Defect

Condition: ☐ Sound ☐ Cracked ☐ Root Intrusion ☐ Loose Brick ☒ **Deteriorated**

Infiltration: ☐ None ☒ **Joint** ☐ Cracks ☒ **Mortar** ☐ Roots ☐ Wall

Adjustment deterioration and infiltration.

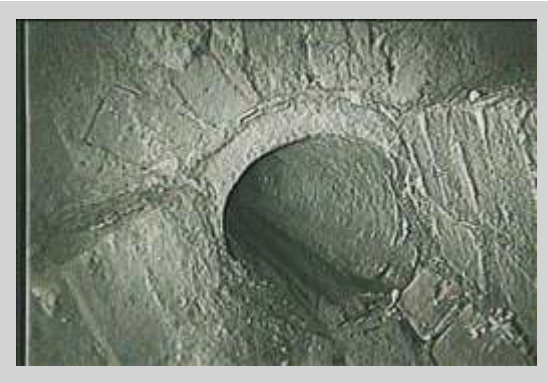
Pipe Out @ 12 O'Clock

Condition: ☐ Sound ☐ Cracked ☒ **Root Intrusion** ☐ Loose Brick ☒ **Deteriorated**

Infiltration: ☐ None ☐ Joint ☐ Cracks ☒ **Mortar** ☒ **Roots** ☒ **Wall**

Condition: ☐ Sound ☐ Cracked ☐ Root Intrusion ☒ **Deteriorated** ☐ Leaks ☐ Debris

Barrel deterioration and infiltration. Channel deterioration.

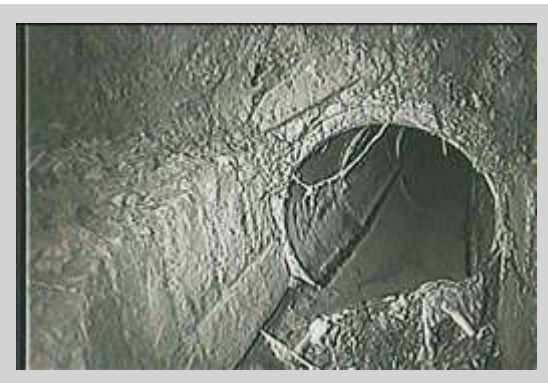
Pipe In @ 9 O'Clock

Barrel root intrusion and infiltration.

Infiltration: **Evidence** Pipe Seal Cond: **Roots**
